# The Architectural Factors in Continuity of Living for the Elderly After Falls and Fractures

**Keywords:** Falls, Fracture, Elderly, Renovation of Homes, Interviews

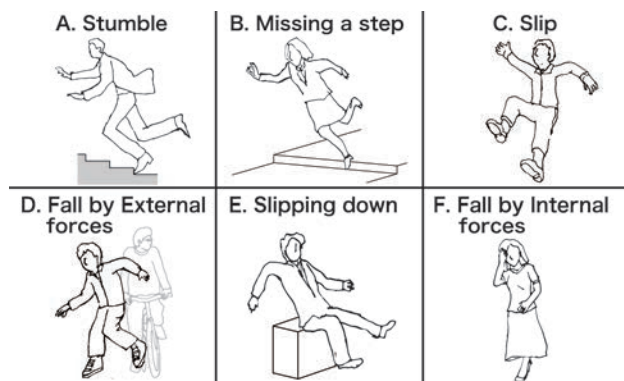
**Fig. 1 Definition of Falls - Fall Model**

Bedside interviews were conducted at the University of Tokyo Hospital. Patients were asked about their injuries and whether they fell or not was confirmed using a fixed definition of falls (**Table 1**, Imaeda, 2017) and fall models (**Fig. 1**, Imaeda, 2017). The physical conditions before falls were tested using GLFS-25 (Seichi, 2012). Fall situations (e.g., place, time, what to do at that time, etc.) and the living environment (e.g., living alone or with families, type of house, etc.) were assessed after patients entered the hospital.

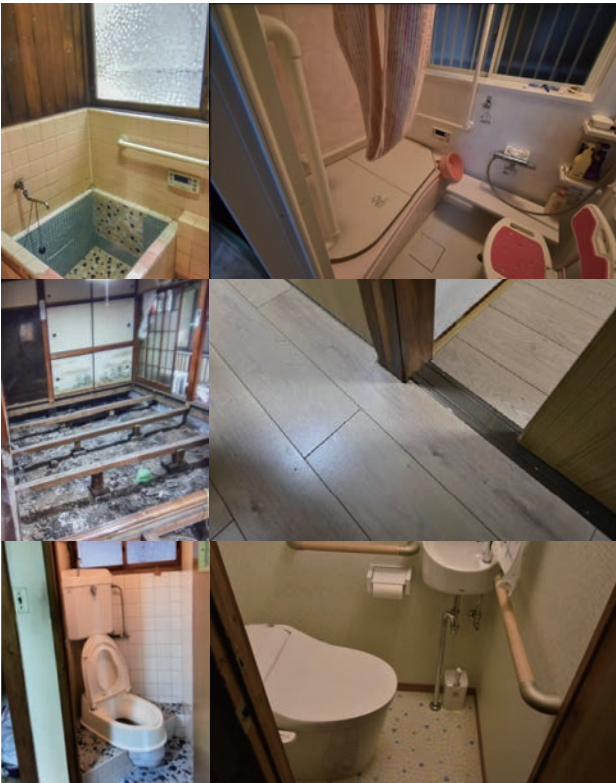
Fig. 3 Before(Left) & After(Right) Repair in No.4: Bathroom(Above), Living Room(Middle), Toilet(Bottom)

There were much renovation in the patient's house; however, some renovation confused her such as the new washing machine and the new kitchen. The operation of these appliances changed from what she was used to; therefore, due to her dementia, sometimes her daughter helped through telephone. In addition, a new veranda, intended for drying laundry, was not used. Instead, the patient used the bathroom and a dry heater for that purpose.

This patient had dementia after she went back home, but it was not clear if the dementia was related to her fall. She lived alone before she fell and this did not change. Her daughter and son came to her house frequently and they had an important role in the renovation of her house, which was done after she fell and completely change the house (**Figs. 3, and 4**). In particular, her daughter lived far from her house (it took 90 minutes by train) and she stayed 2 or 3 days every week. She referred to the renovation during the bedside interview.

| No. | Sex | Ages at Bedside Interviews | Dementia | GLFS-25 Before Falls | GLFS-25 After Falls | Living Type | Type of House | Fall Place | Repair of House Before Falls (A) | Contents of Repair (A) | For Whom | Repair of House After Falls (B) | Contents of Repair (B) | Who Decided to Repair Mainly | Moving |
|---|---|---|---|---|---|---|---|---|---|---|---|---|---|---|---|
| 4 | F | 86 | No (Bedside Interview)<br>↓<br>Yes (Home-Visit Interview) | 41 | 15 | Live Alone | Detached House | Corridor of Hospital | No | - | - | Yes | Change Material of Floor (Living and Bedroom), Installation of Handrail for Entrance, Change the Bathroom, Washroom and Kitchen, Change type of Toilet (From Japanese Style to Western Style), Elimination of Steps Out of Entrance, etc. | Patient's Son and Daughter (Not Living with Patient) | No |
